Northern Star Marine  
**NARROWBOAT SURVEYS**

**....Survey Report....**

For the purpose of: **Full Survey**

<b>Name:</b>	.....	<b>Type:</b>	Cruiser style Narrowboat
<b>Builder:</b>	Harborough marine	<b>Fit-out:</b>	Owner
<b>Approx. Year of build:</b>	1979	<b>Index:</b>	.....
<b>CIN No:</b>	Not applicable	<b>Max Length:</b>	49ft 6In
<b>Max Beam:</b>	6ft 10in	<b>Max Draught:</b>	2ft 2in

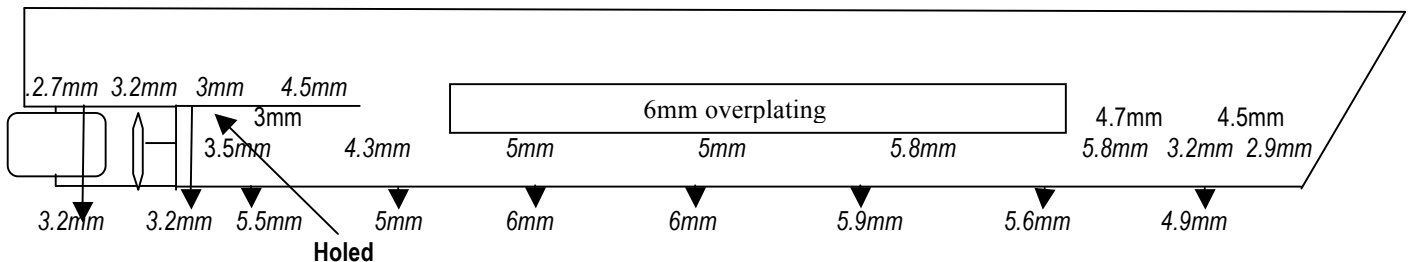
### Starboard readings:

From the sample areas selected, ultrasonic measurements show the plate thickness to be between 1mm and 5mm which are not within acceptable limits. The lower readings were taken at the bow, transom, and at the counter swim which is due to internal corrosion. A small section on the starboard side counter swim was holed. A small section of the transom was also holed.

From the sample areas selected at random, ultrasonic measurements show the plate thickness to be between 3.2mm and 5mm which is not within acceptable limits.

**Rec 1:** *Over plate the bow from the stem post to the turn of the swim up to the top of the first rubbing strake. Over plate counter swim. Over plate transom up to the first strake. All using 5 or 6mm steel plate (More detail available on request)*

**Rec 1:** *Over plate the counter with 5 or 6mm steel plate (More detail available on request)*
